# Deep energy retrofit of vernacular housing

An existing ruin of a vernacular house located in a rural area of Portugal is being renovated, aiming for architectural identity preservation and low environmental impact, to offer suitable comfort conditions for tourism exploitation. Calculated global energy consumption reduction is 94% of the calculated current energy use of the building

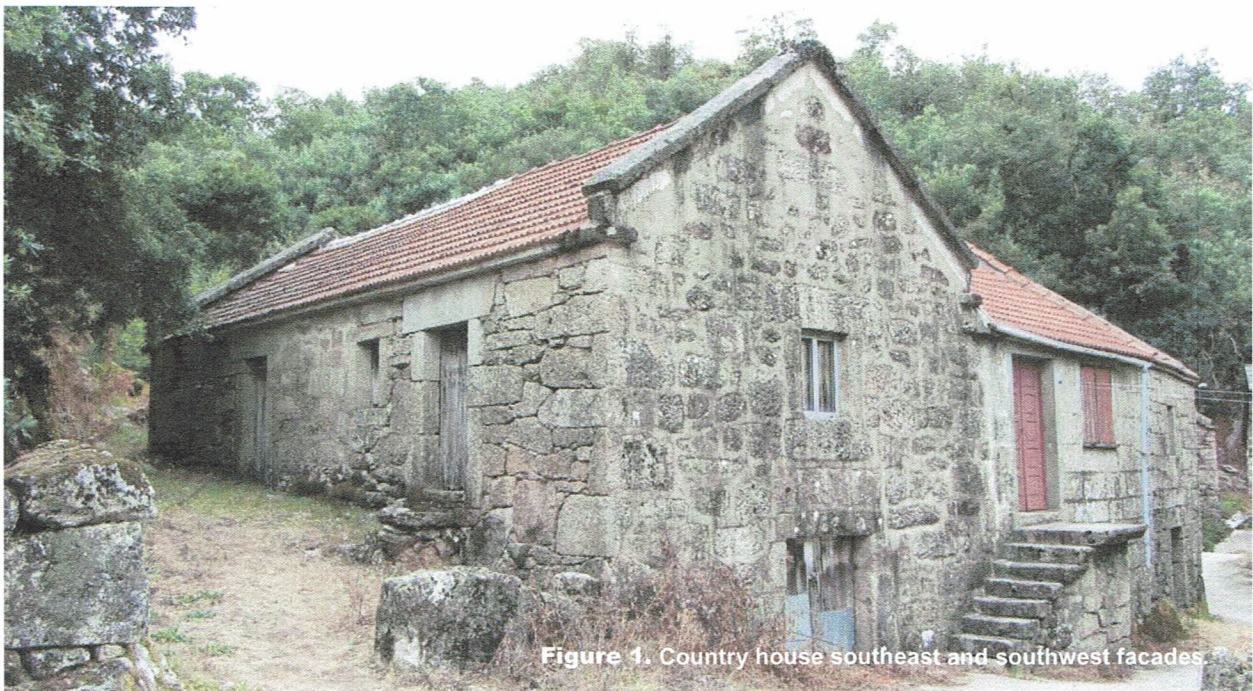
Figure 1. Country house southeast and southwest facades.

The house was originally built in 1940 with traditional vernacular principles (Figure 1), presenting uninsulated granite stone walls, wood structure floors and roof, ground floor in direct contact with soil (animal shelter) and single glazed windows with wooden frames. The external walls are massive but they are loosely arranged in some areas in need of structural reinforcement.
