## BRAIDED FIBRE REINFORCED COMPOSITE RODS FOR CONCRETE REINFORCEMENT

R. Fangueiro<sup>1</sup>, G. Sousa<sup>1</sup>, F. Soutinho<sup>1</sup>, S. Jalali<sup>2</sup> and M. de Araújo<sup>1</sup>

<sup>1</sup>Department of Textile Engineering, University of Minho

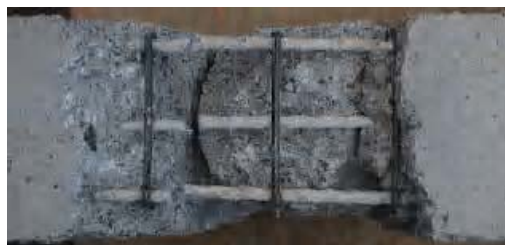
Figure 10 – Beam produced with braided reinforced composite rods after testing

Figure 10 presents a beam after testing. The broken braided reinforced composite rods are shown.
